# **Rail Shipments Of Diluted Tar Sands:**

# **THE AFTERMATH**

# PHOTOS | Oil pooling at creek near Gogama train derailment: Environment Ministry

## Why bitumen isn't necessarily safer than Bakken

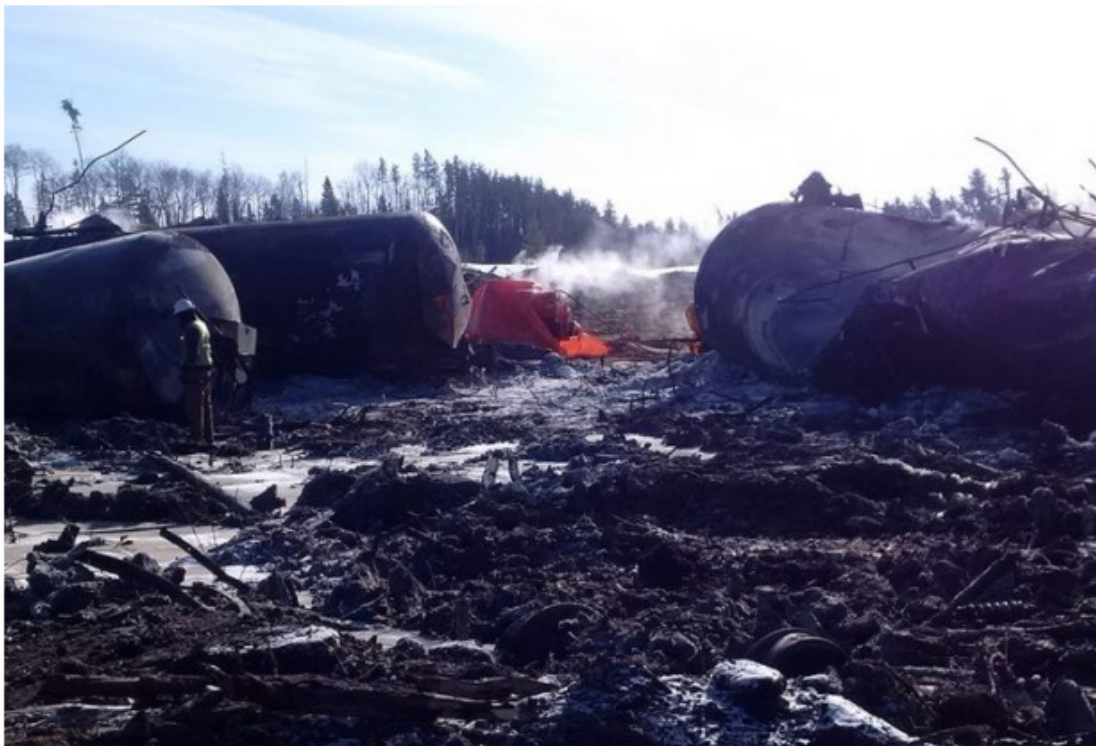
Transportation Safety Board inspectors assess the site and the damaged cars in the train derailment near Gogama, Ont. (TSB)

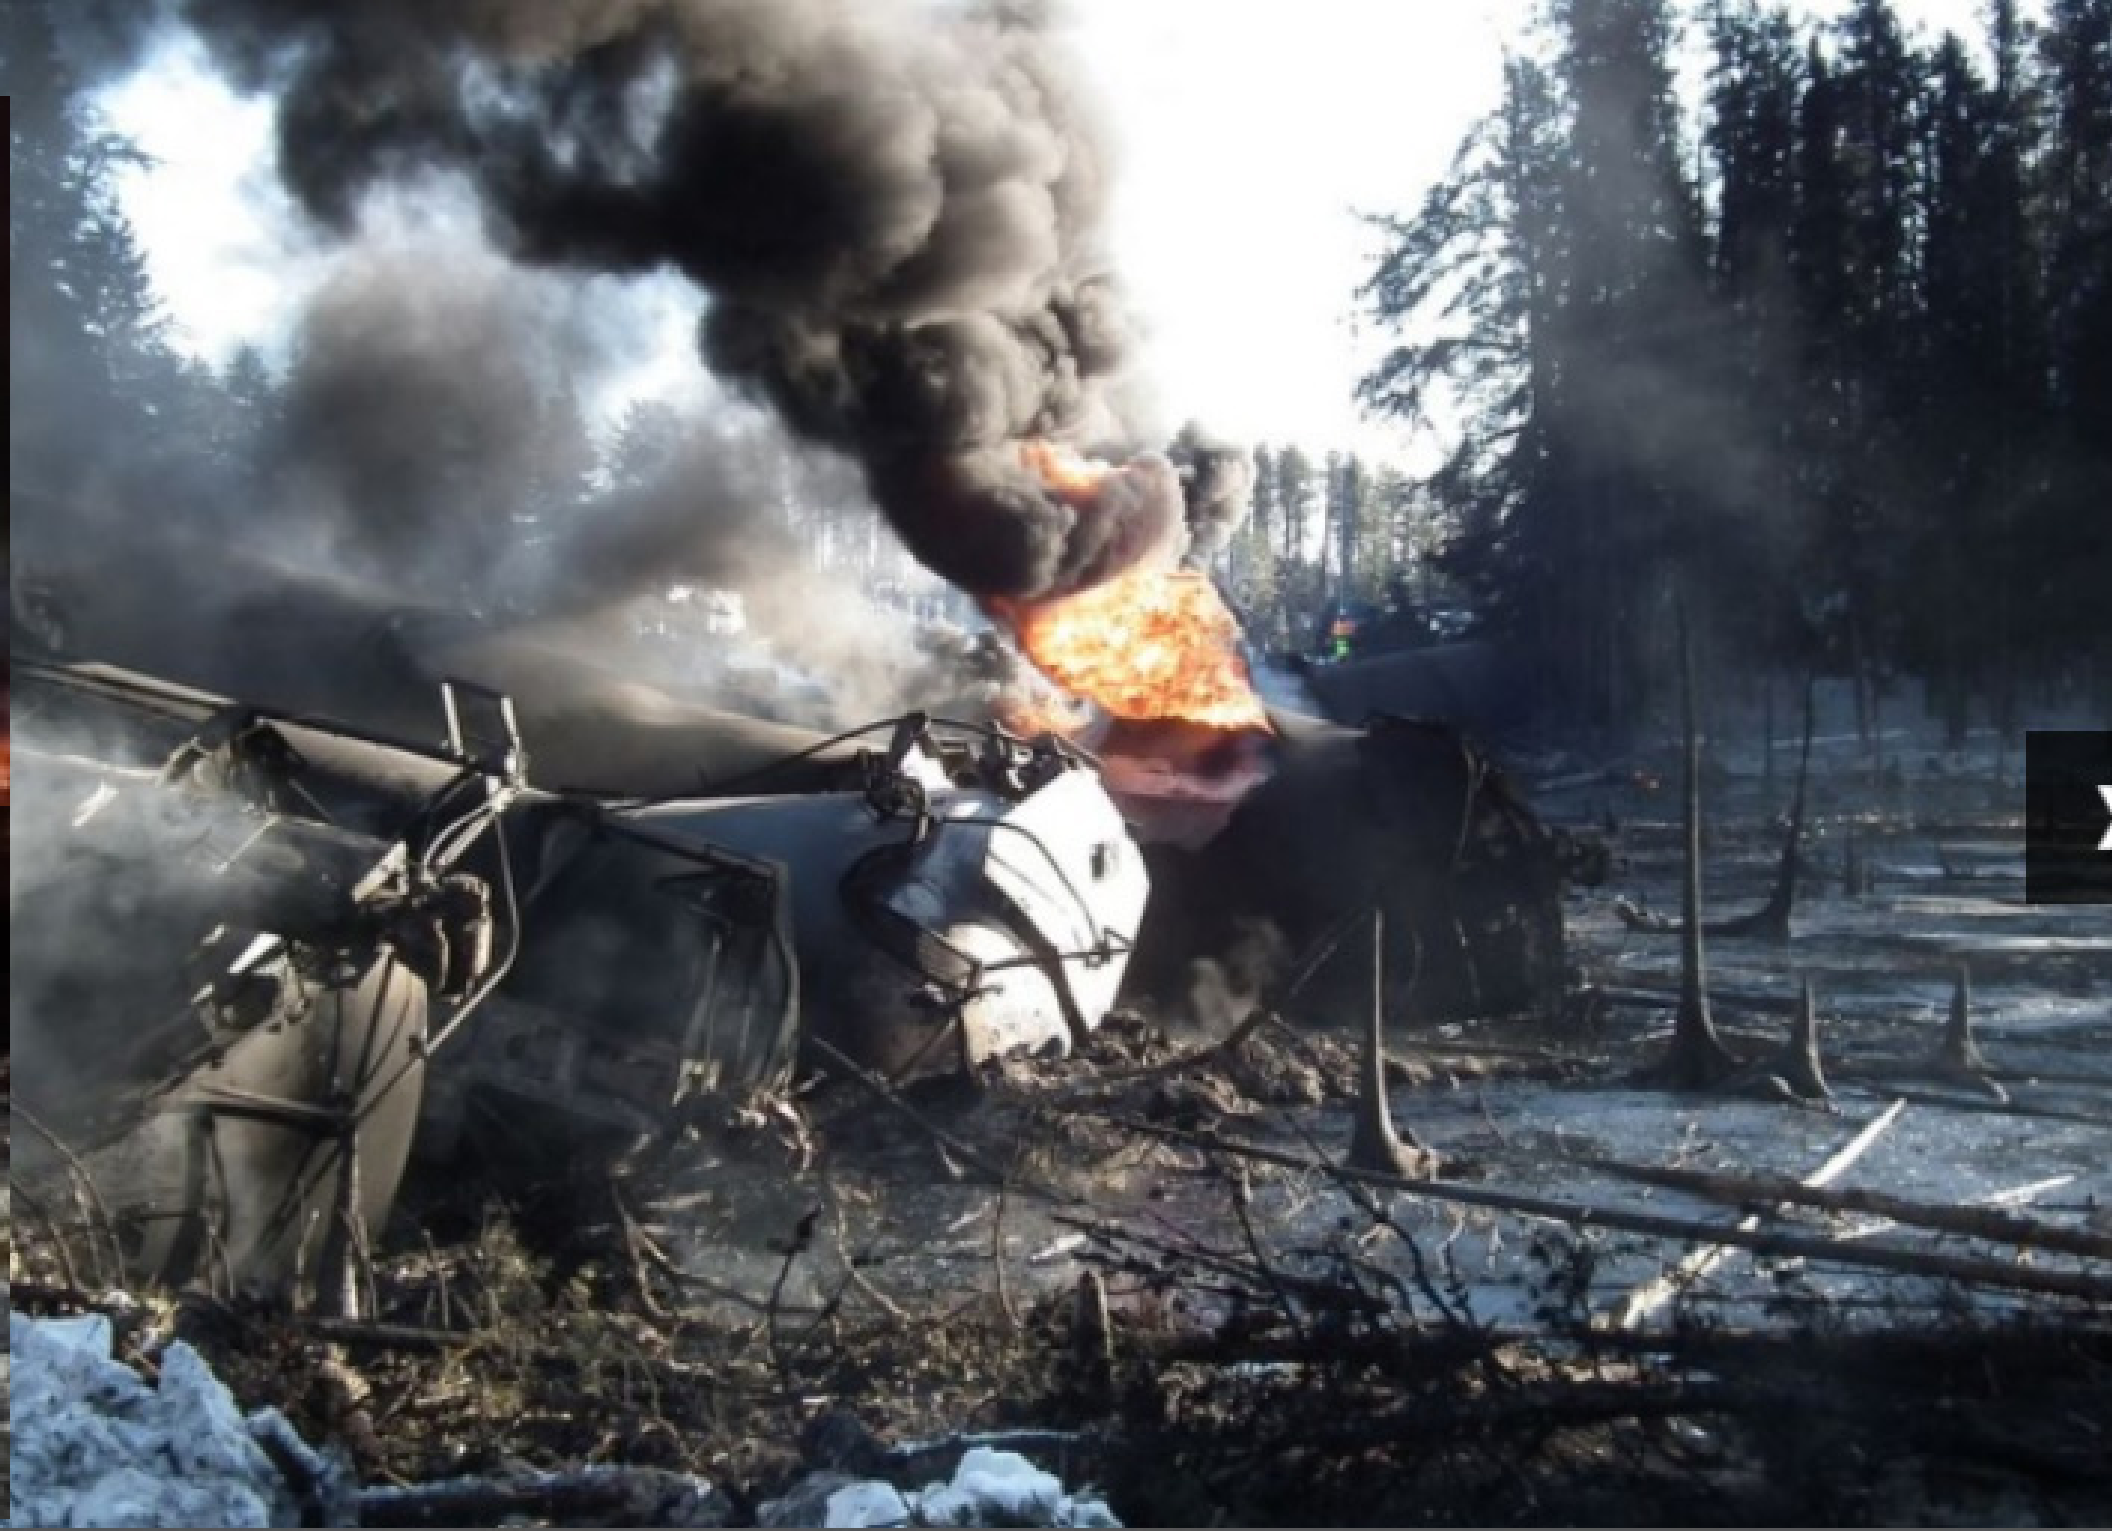
A ruptured tank car burns near Gogama, Ont. (Transportation Safety Board)

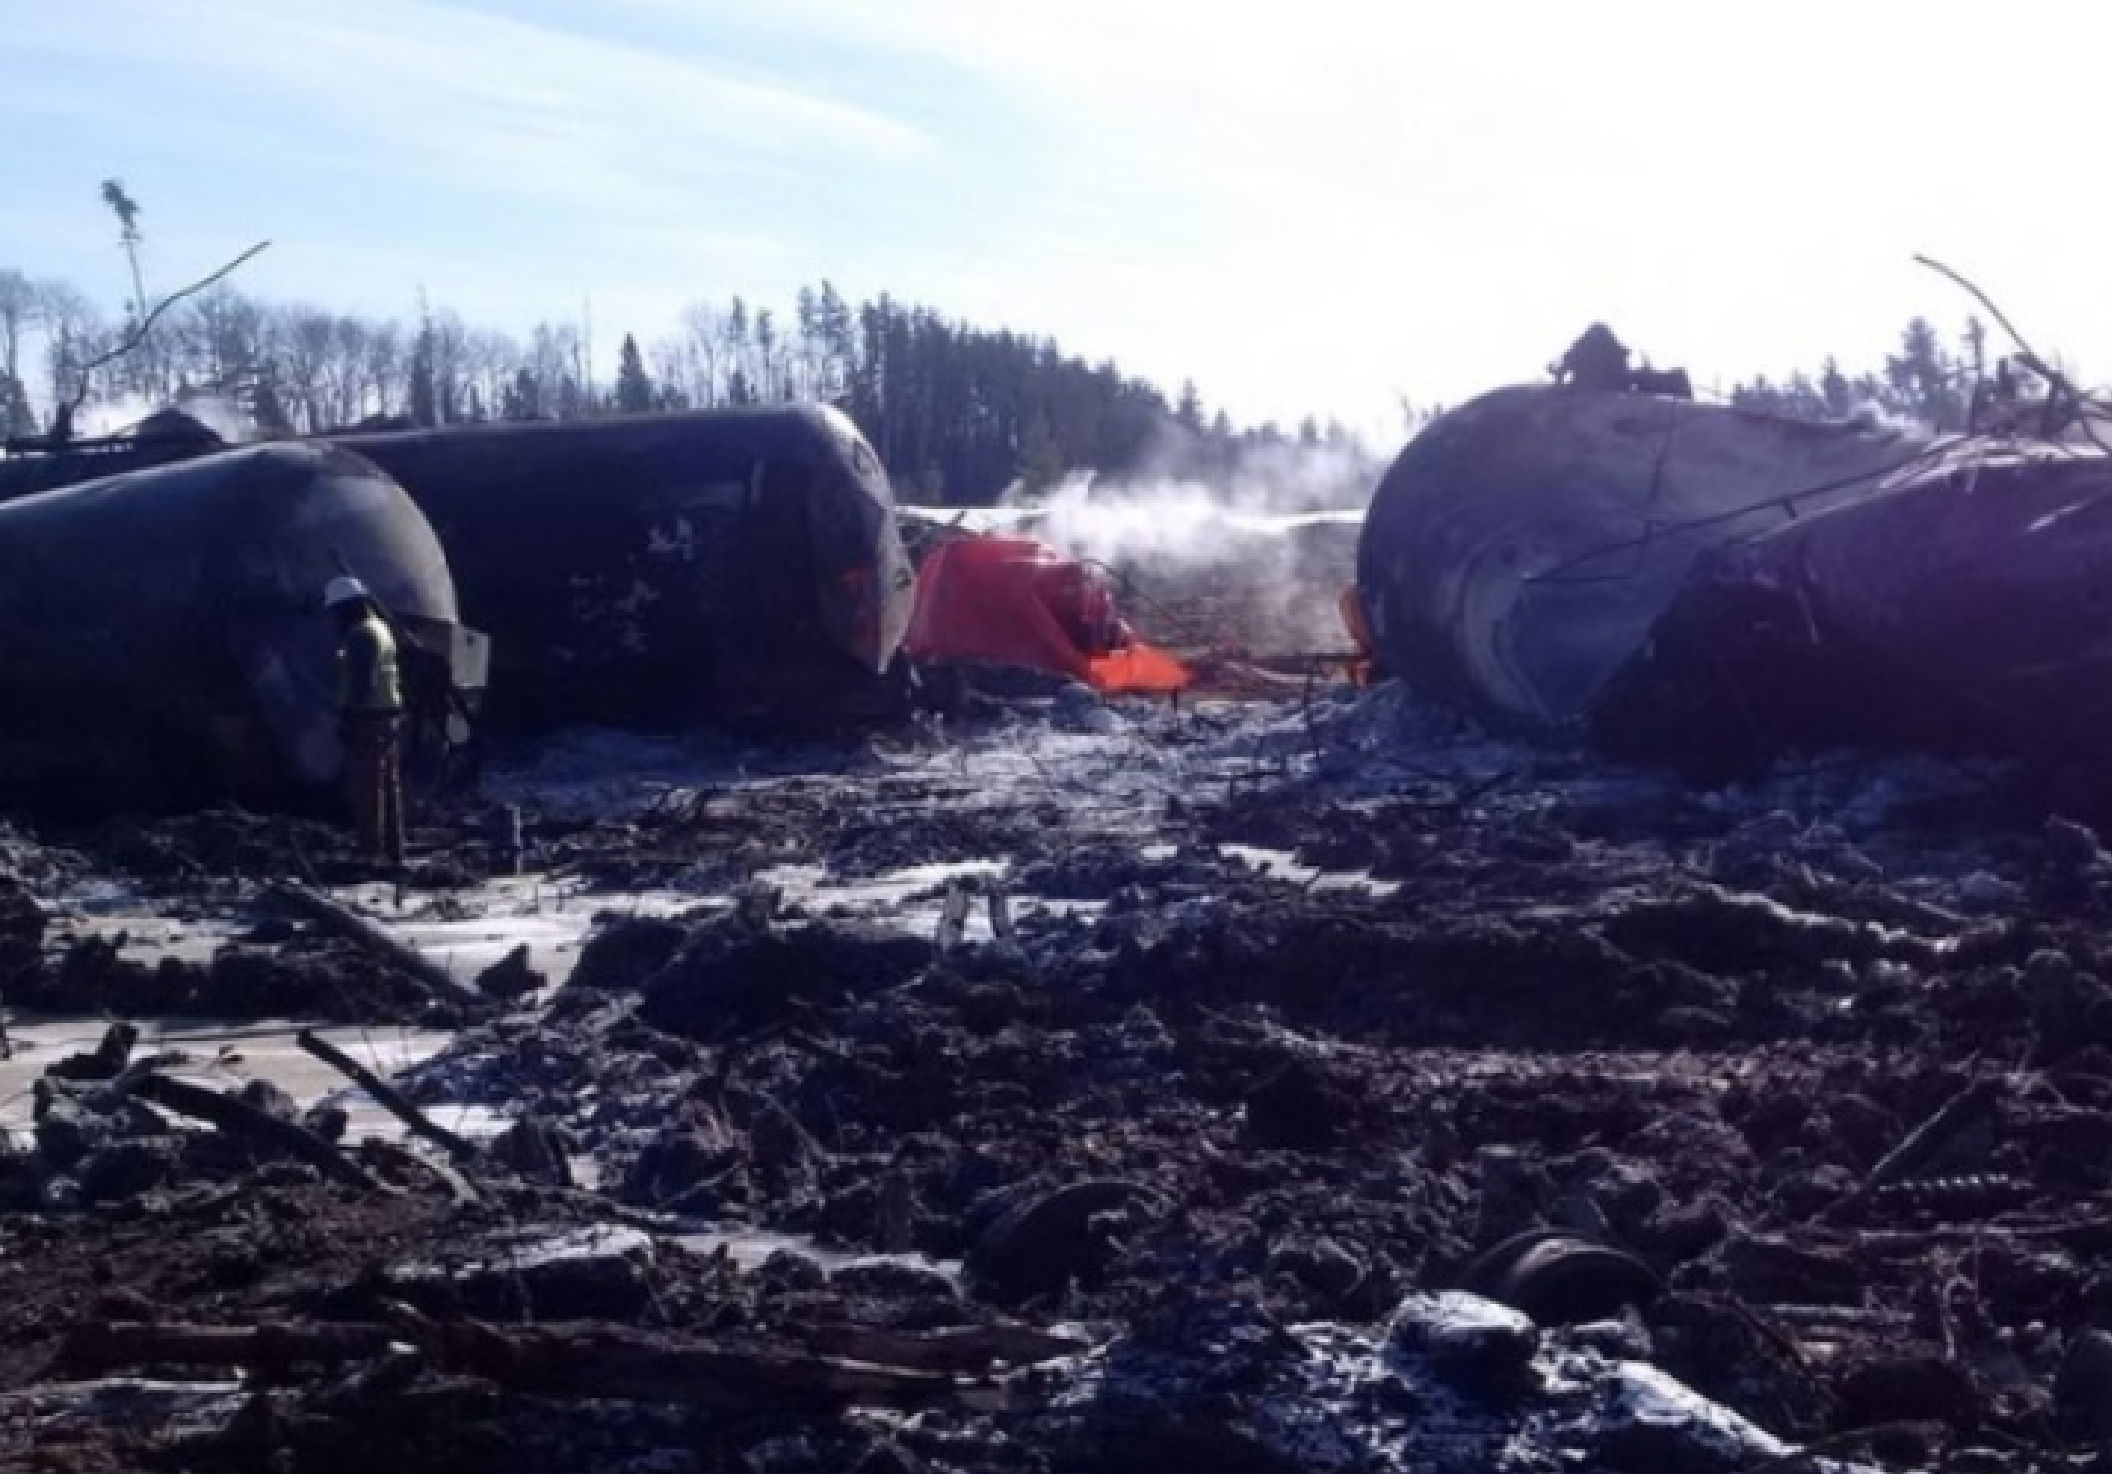
Transportation Safety Board inspectors assess the site and the damaged cars in the train derailment near Gogama, Ont. (TSB)

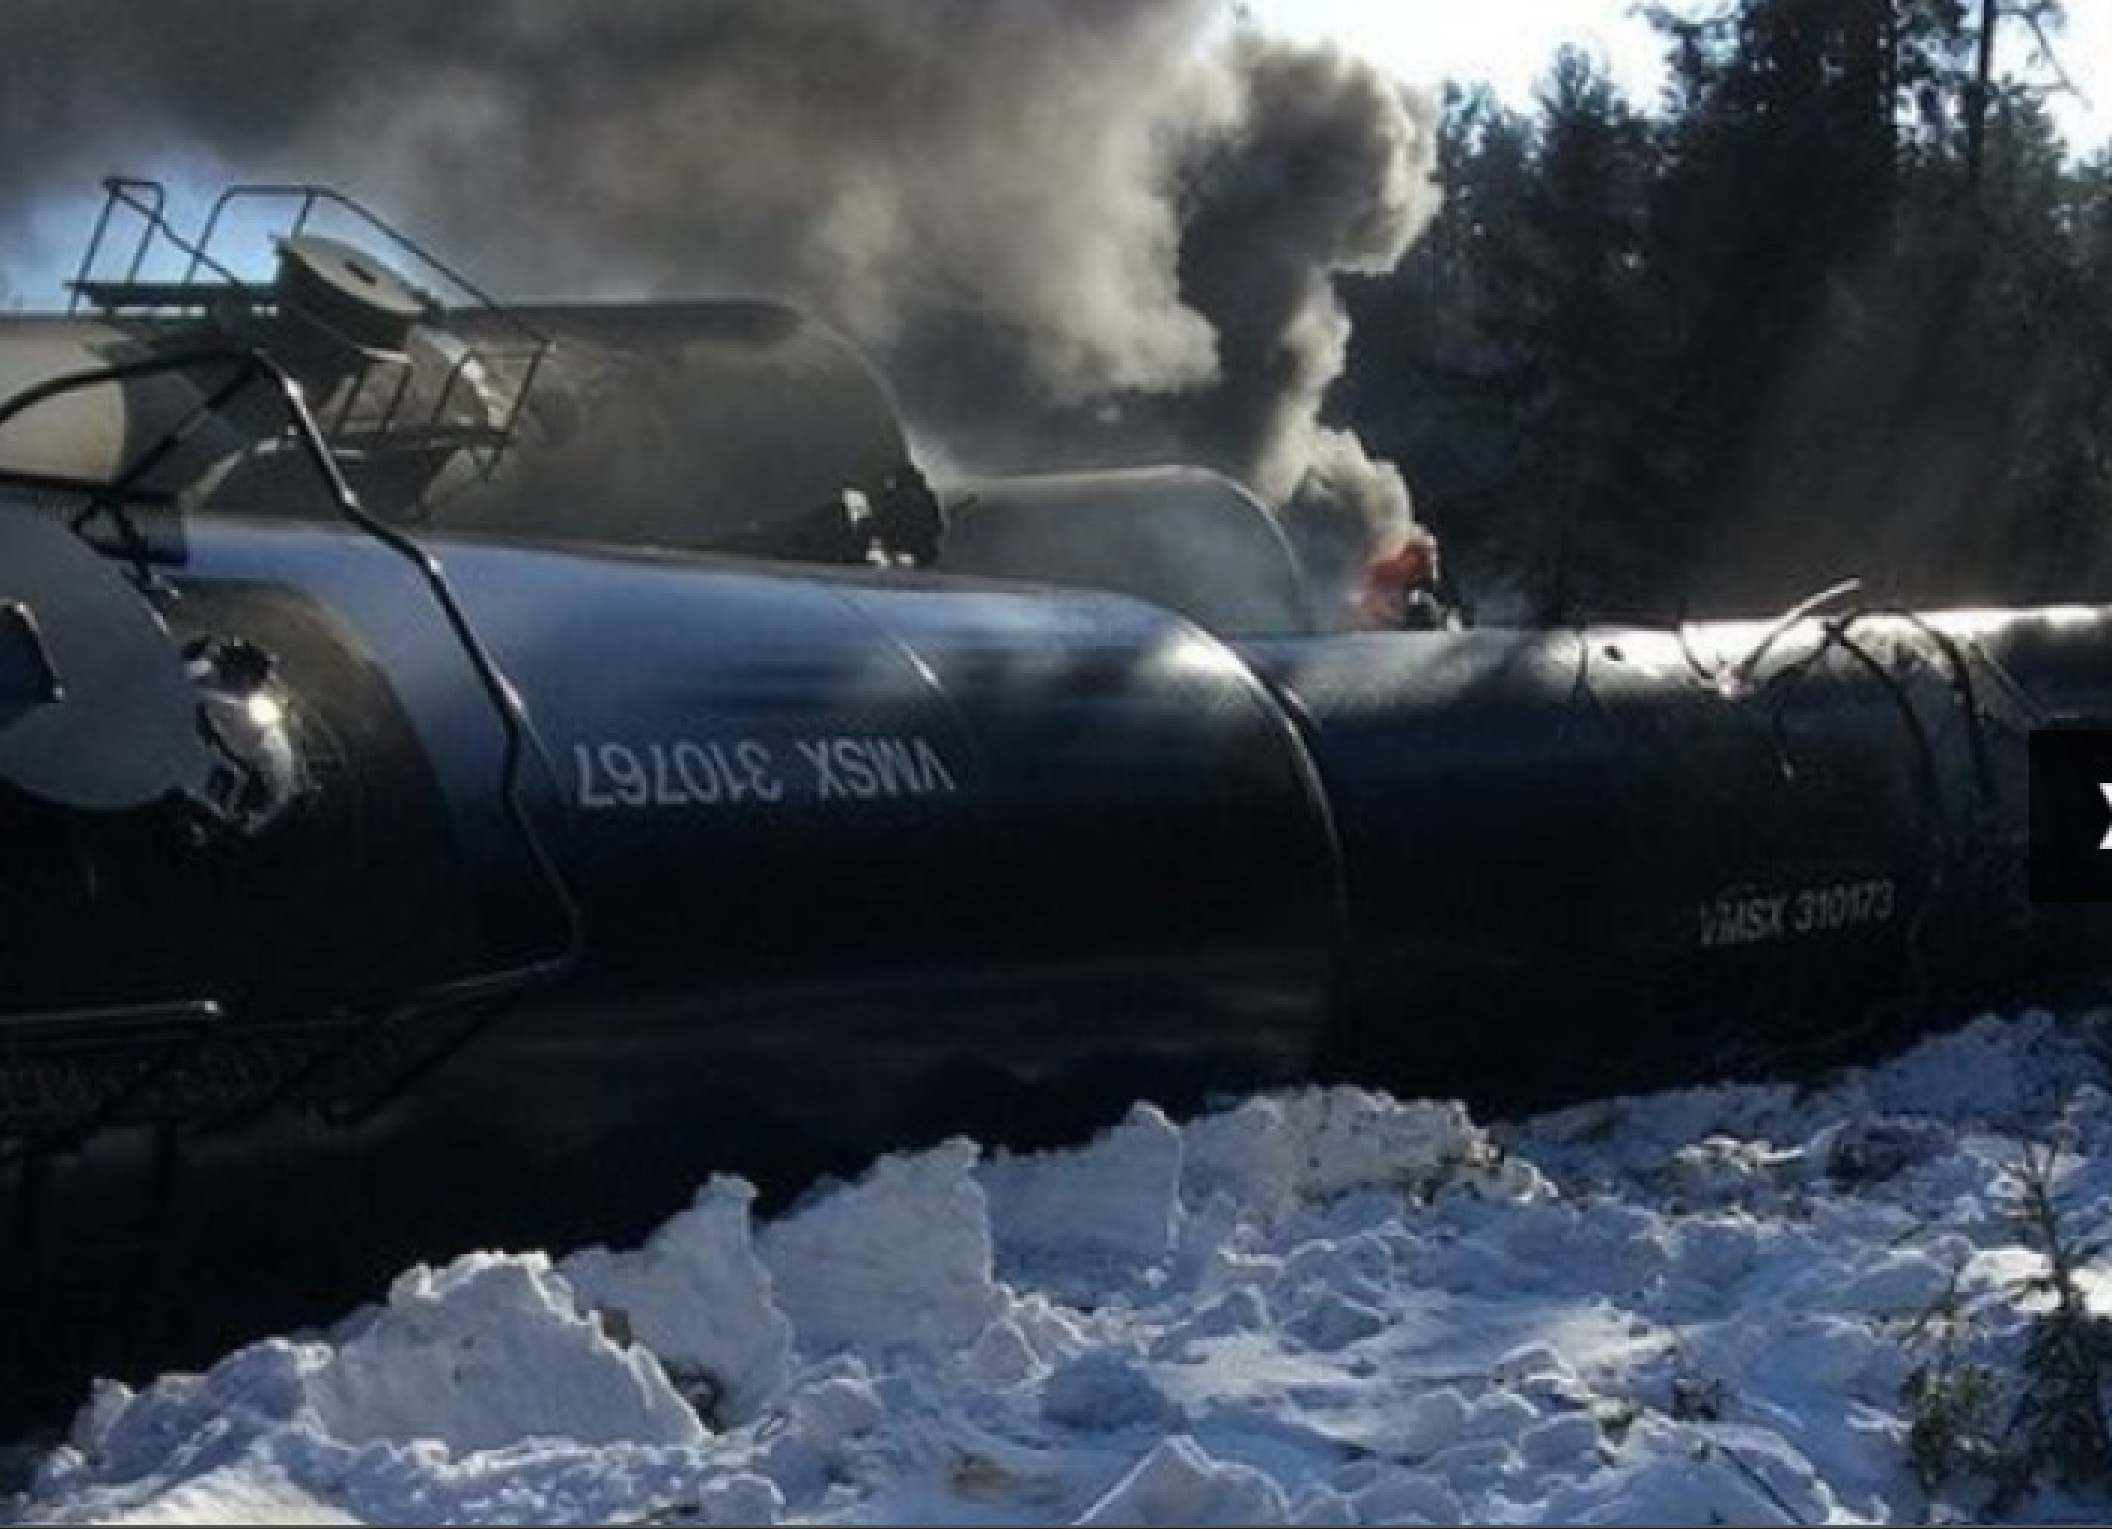
Derailed train cars up close. A total of 29 cars went off the rails on Feb. 14. (Transportation Safety Board)

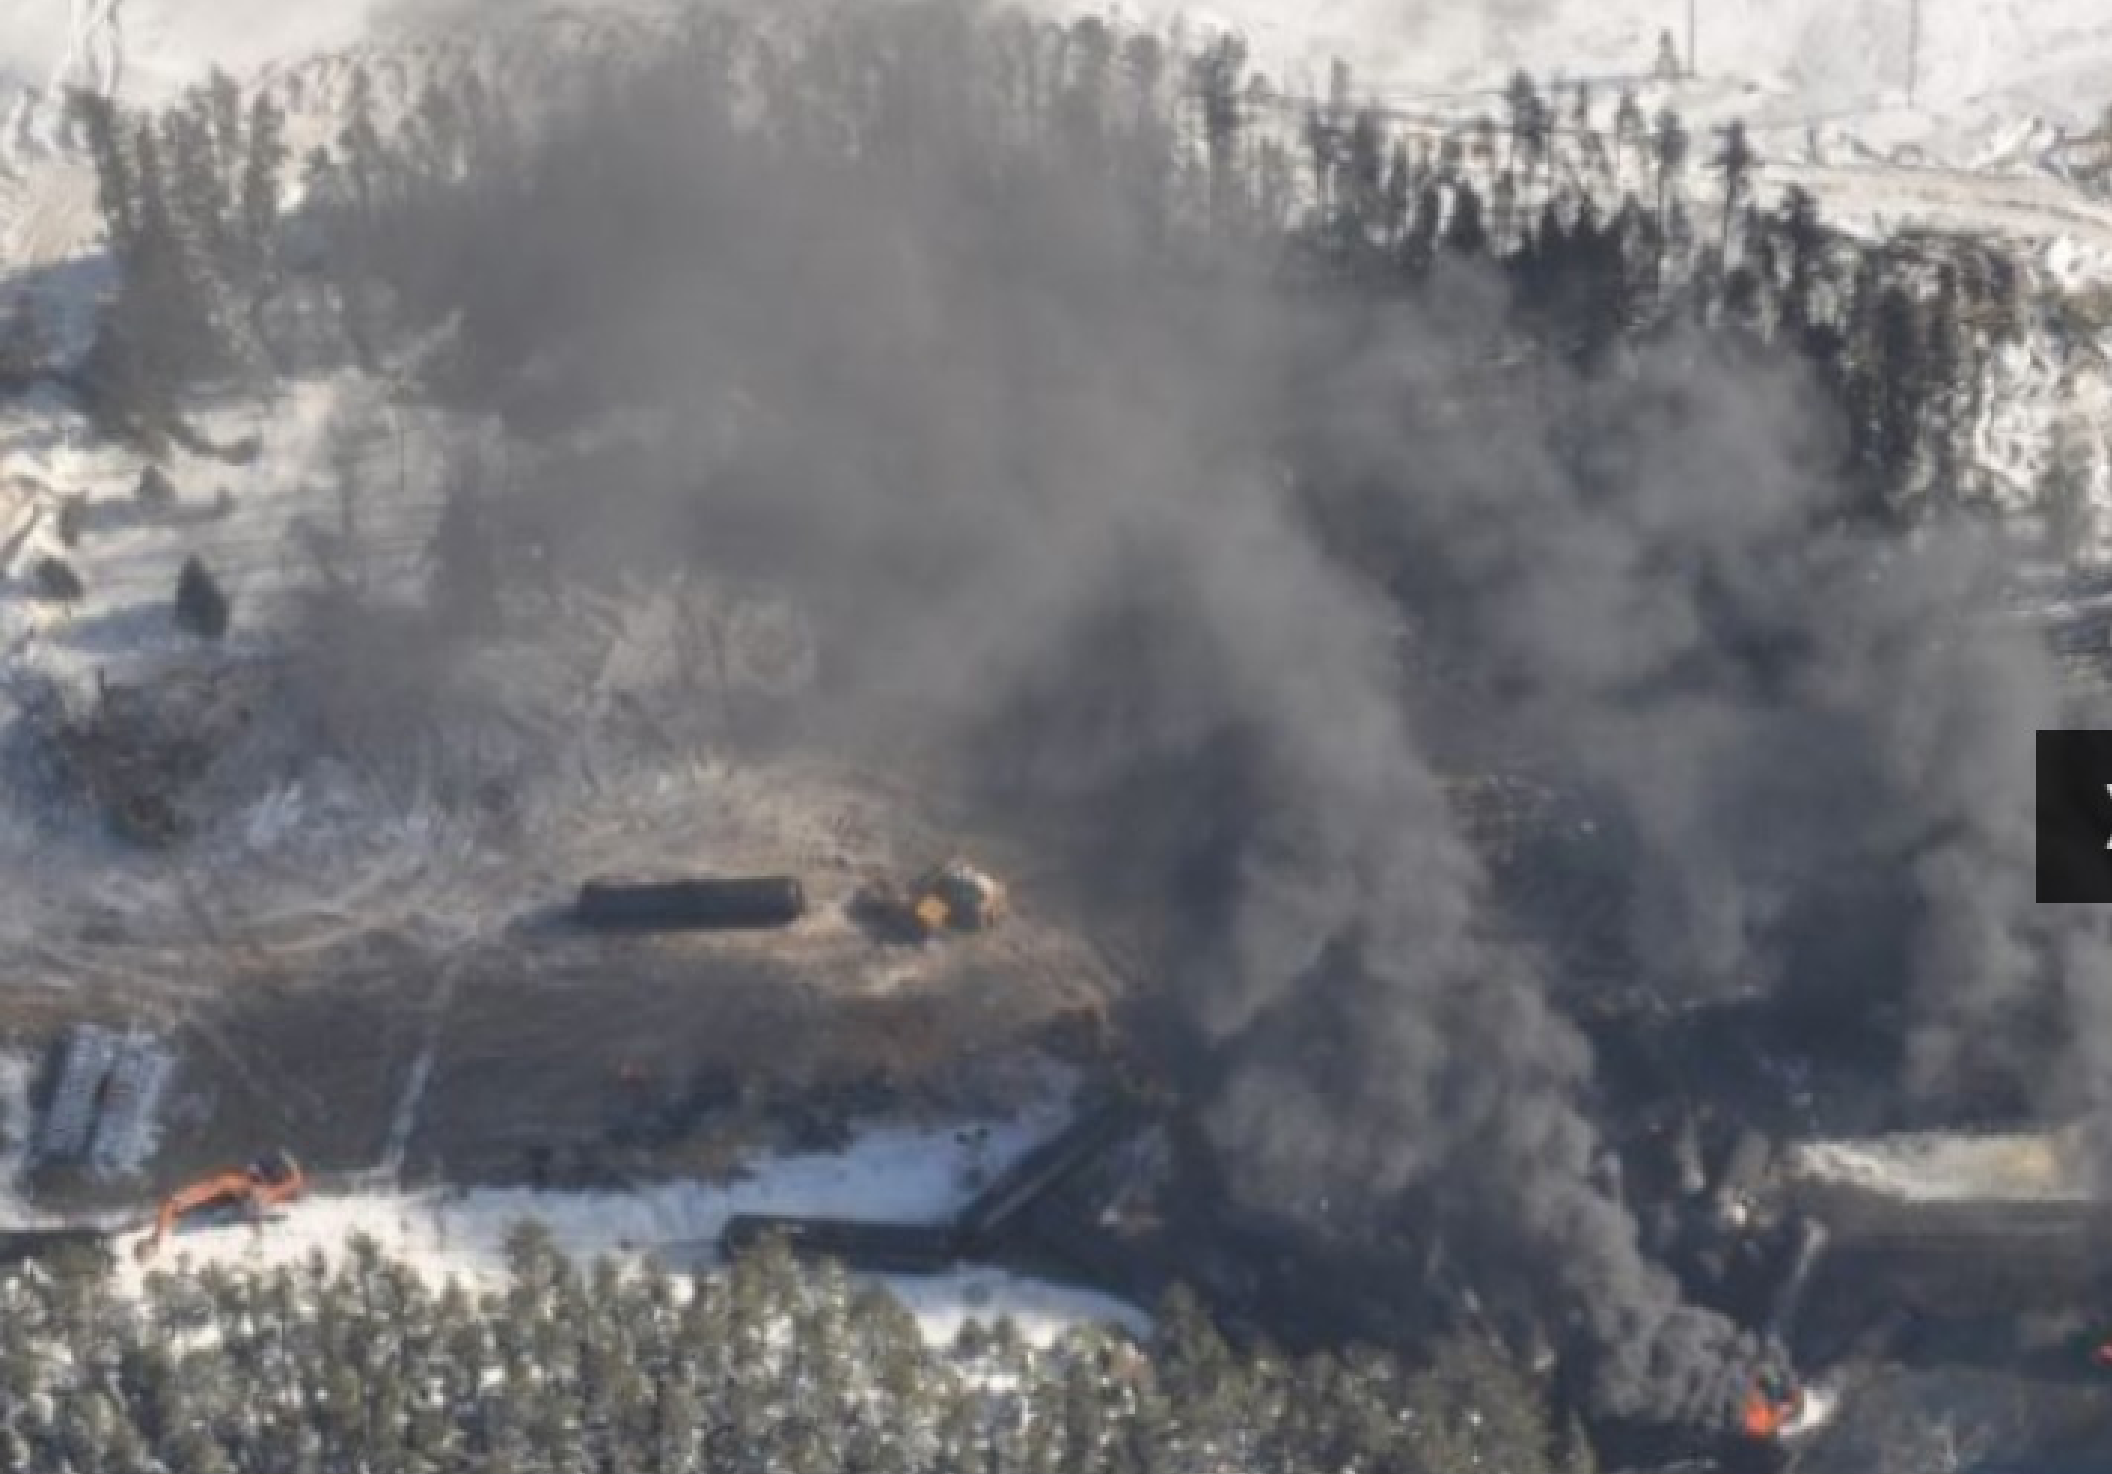
TSB investigators are looking at a couple of clues about what might have happened, including a section of broken rail containing a rail joint, and also a broken wheel. (Dillon Daveikis)

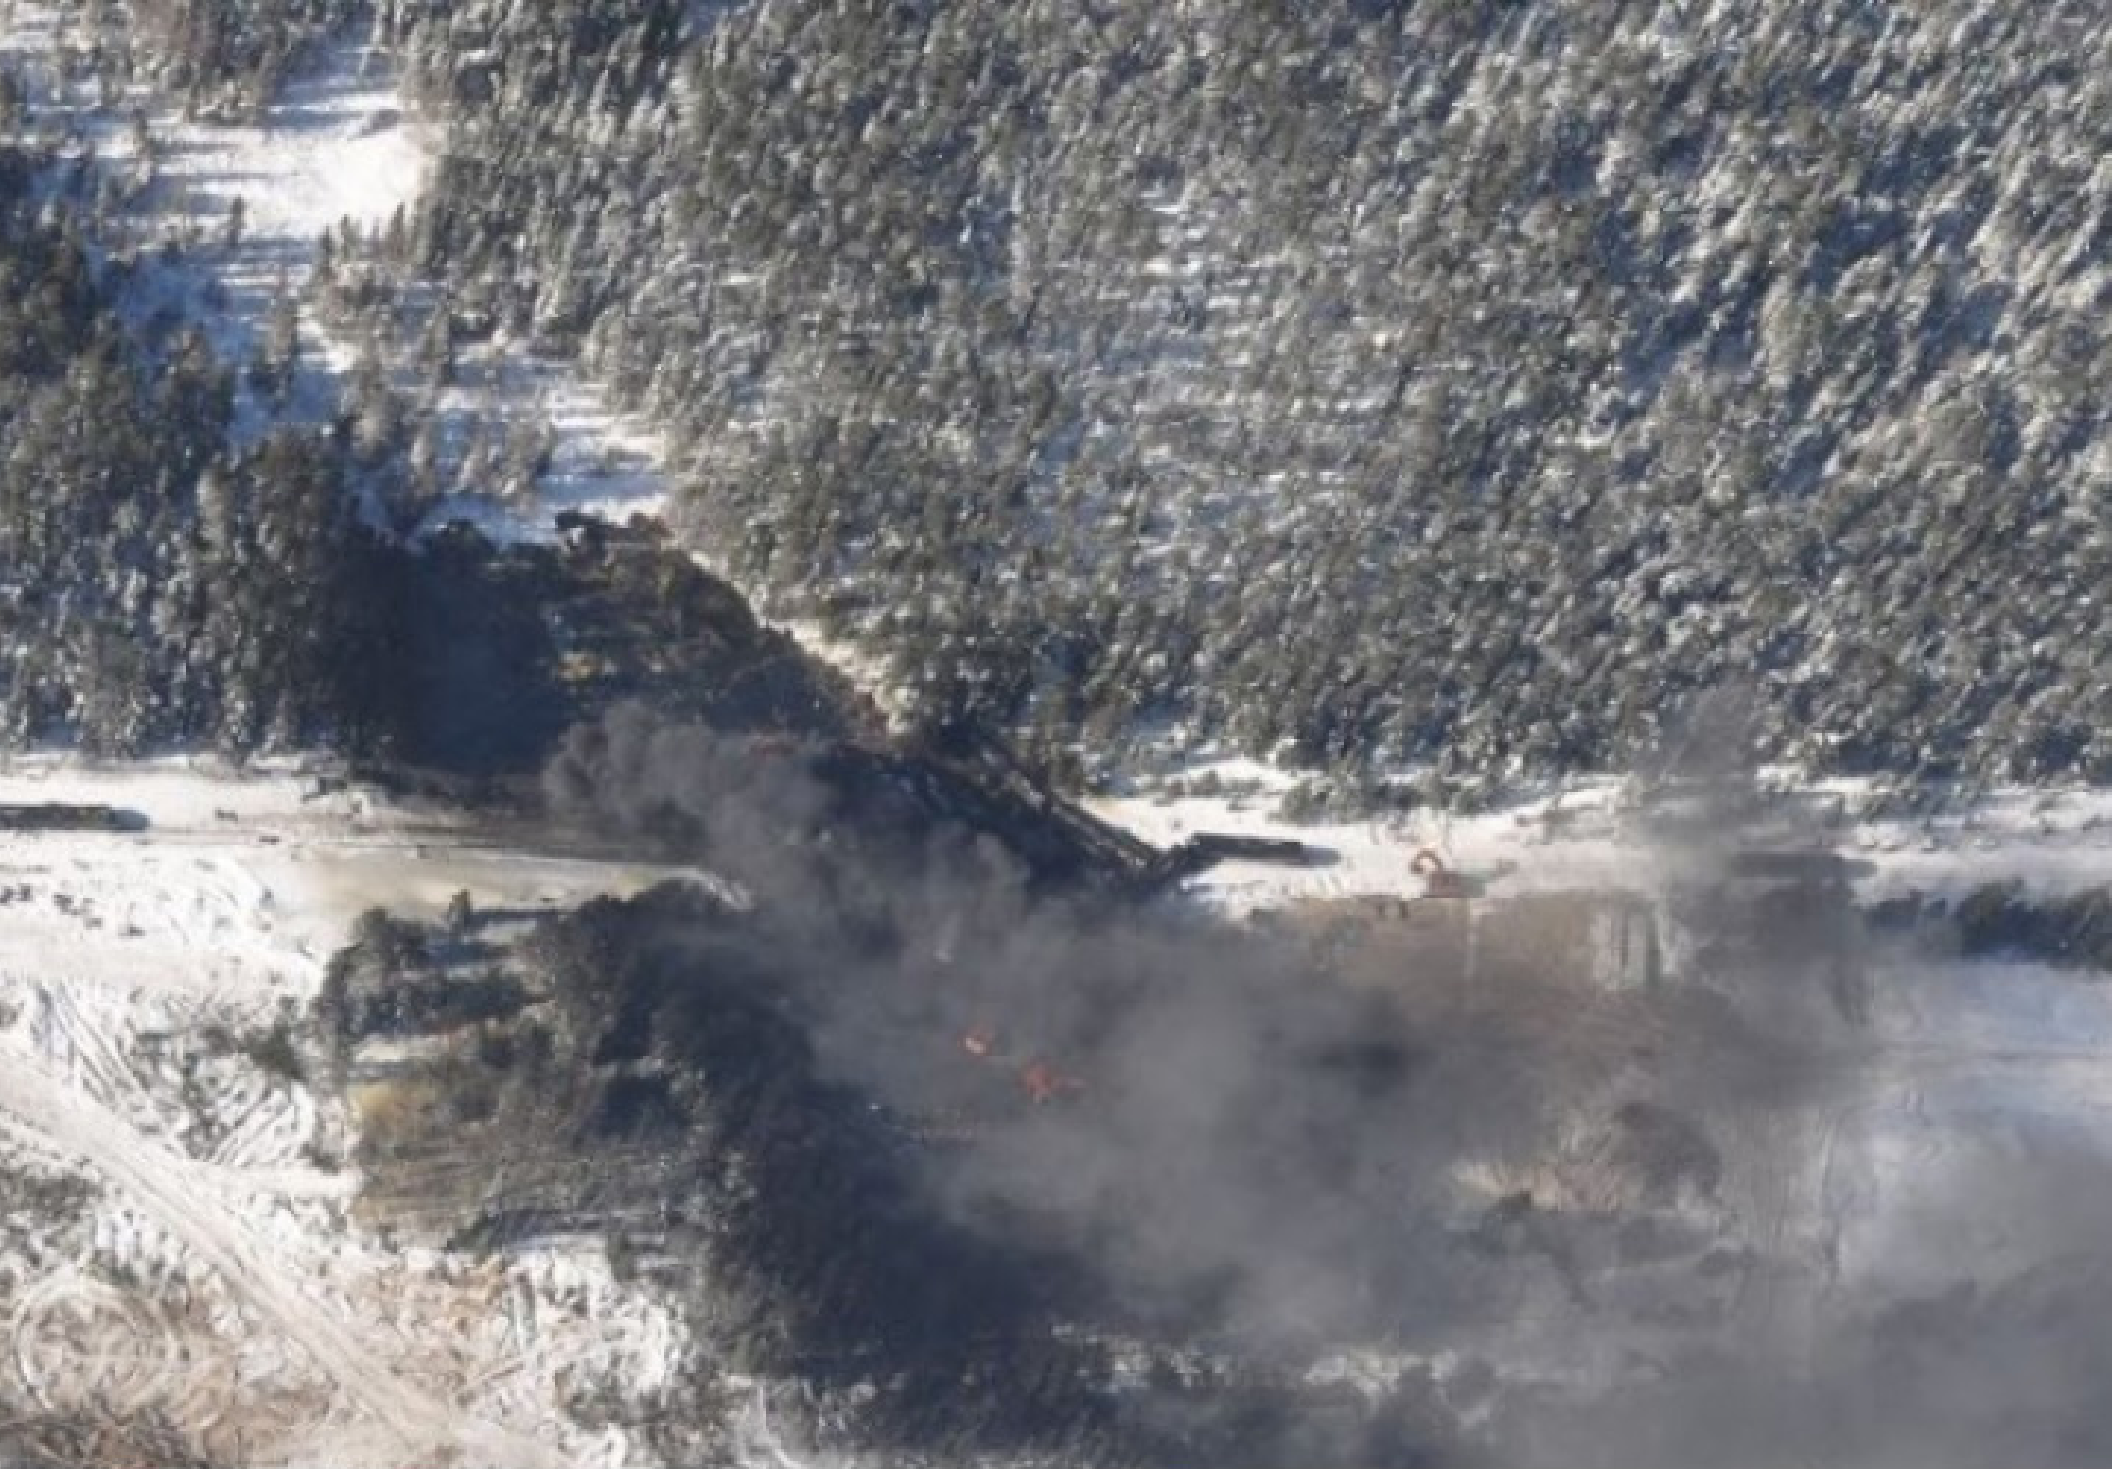
The Transportation Safety Board says 15 cars were breached and are releasing oil after a train derailment near Gogama this weekend. (Dillon Daveikis)

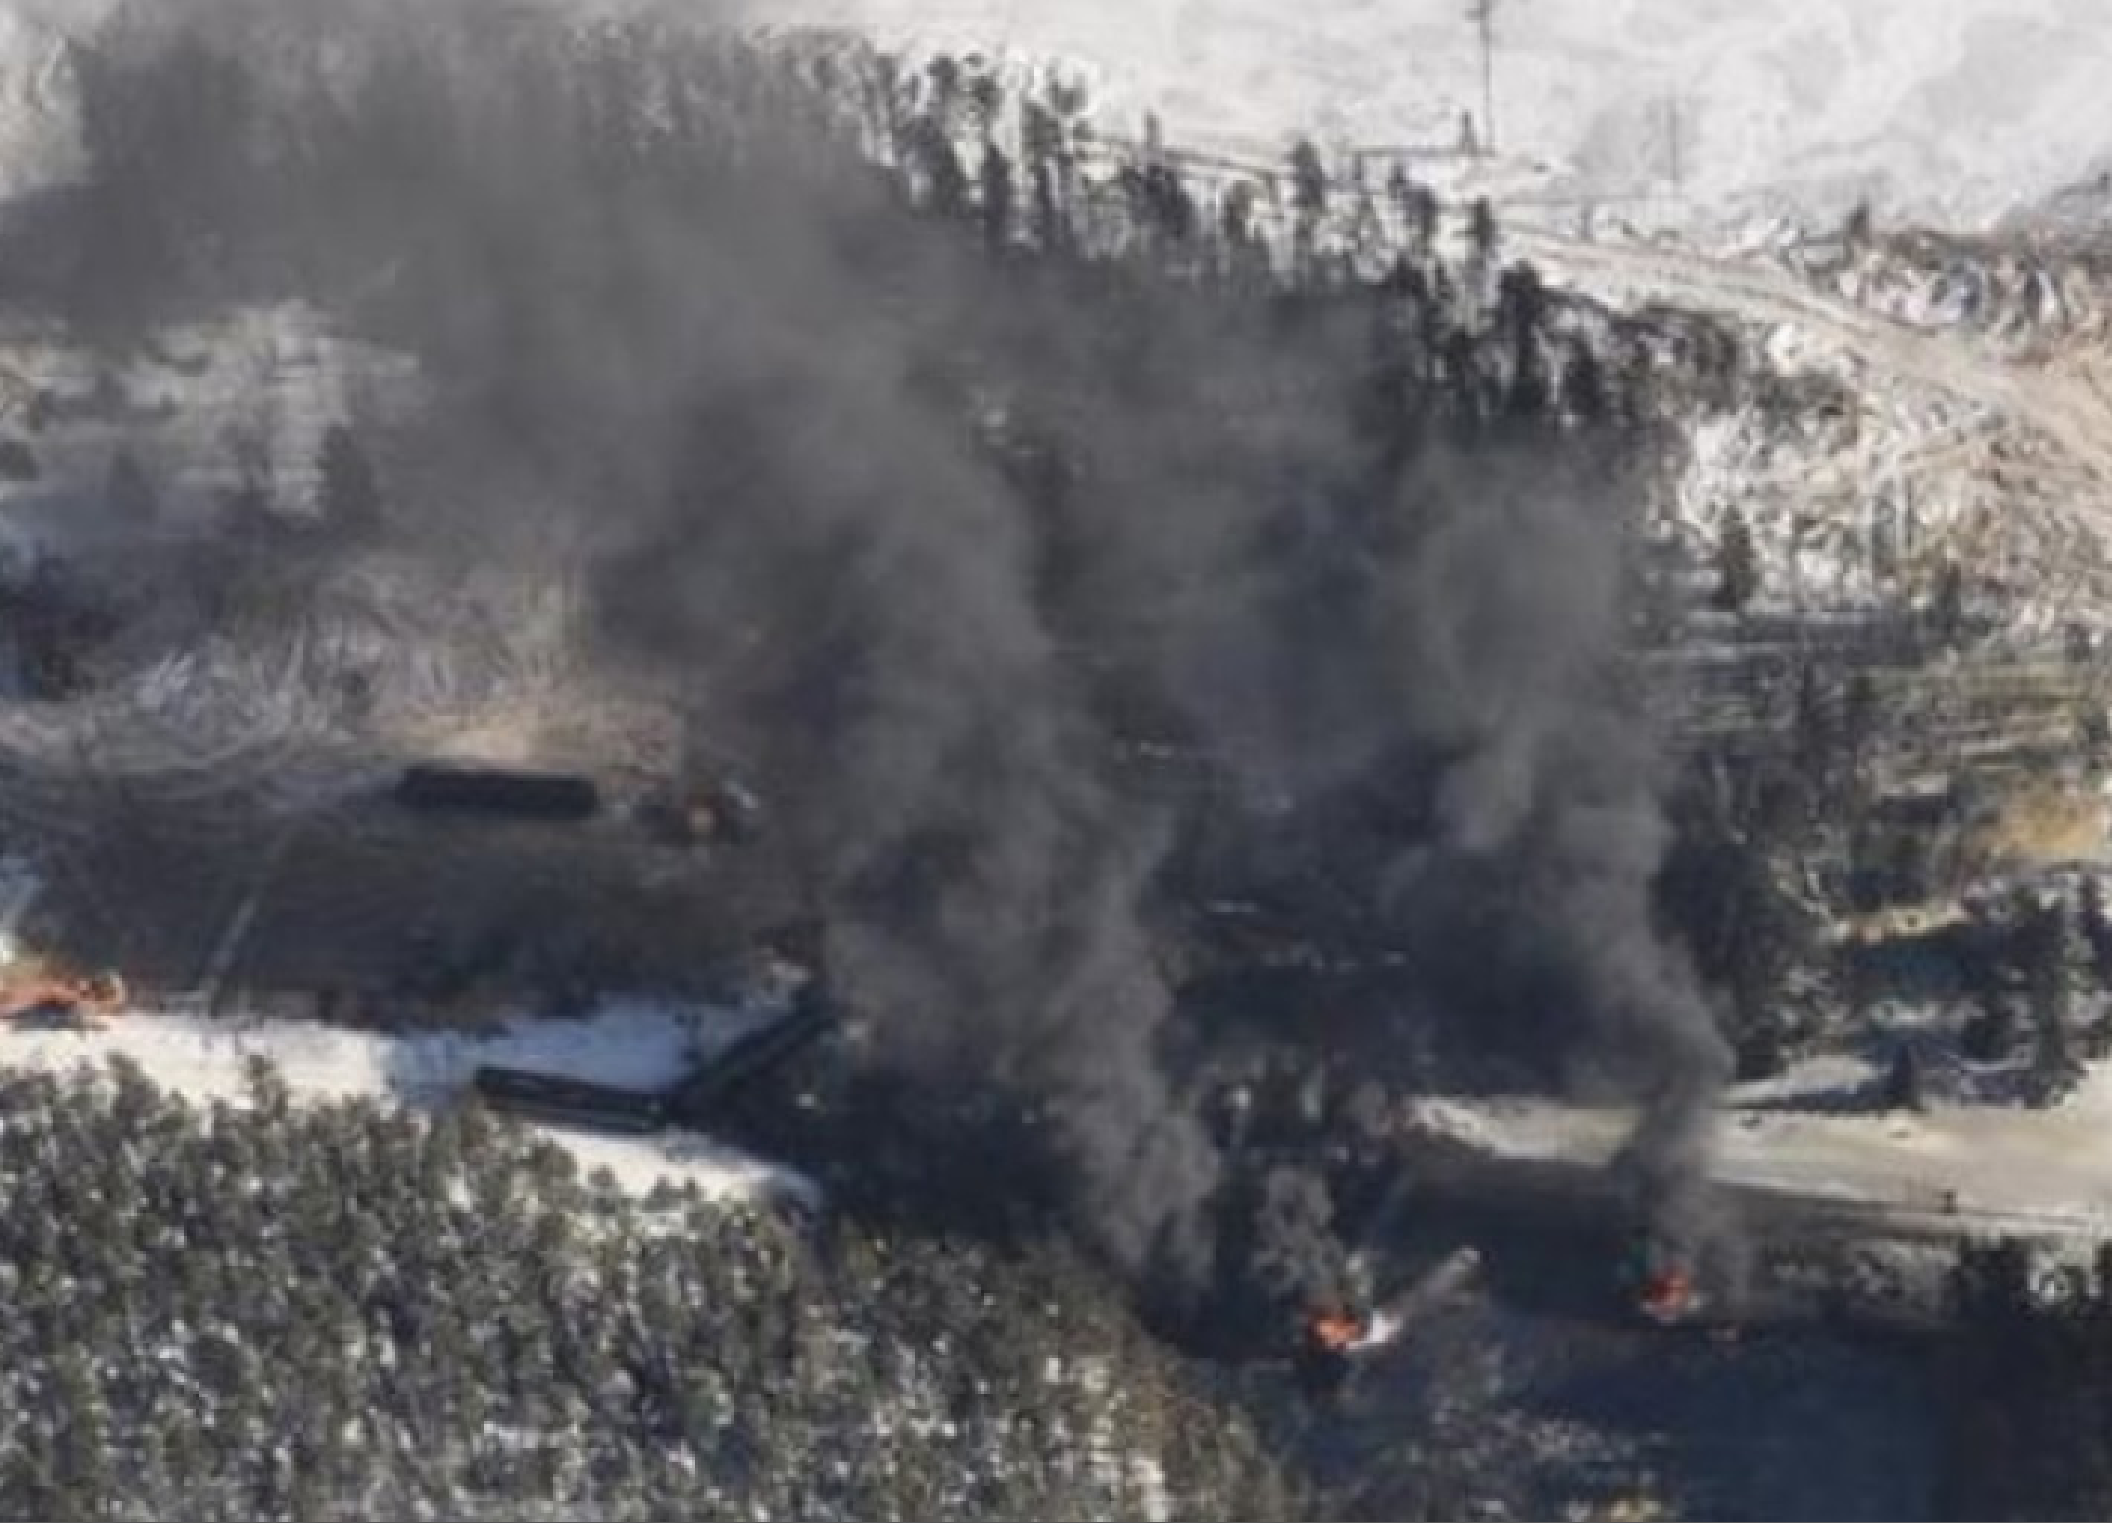
CN says 29 cars carrying crude oil from Alberta jumped the tracks late Saturday. (Dillon Daveikis)

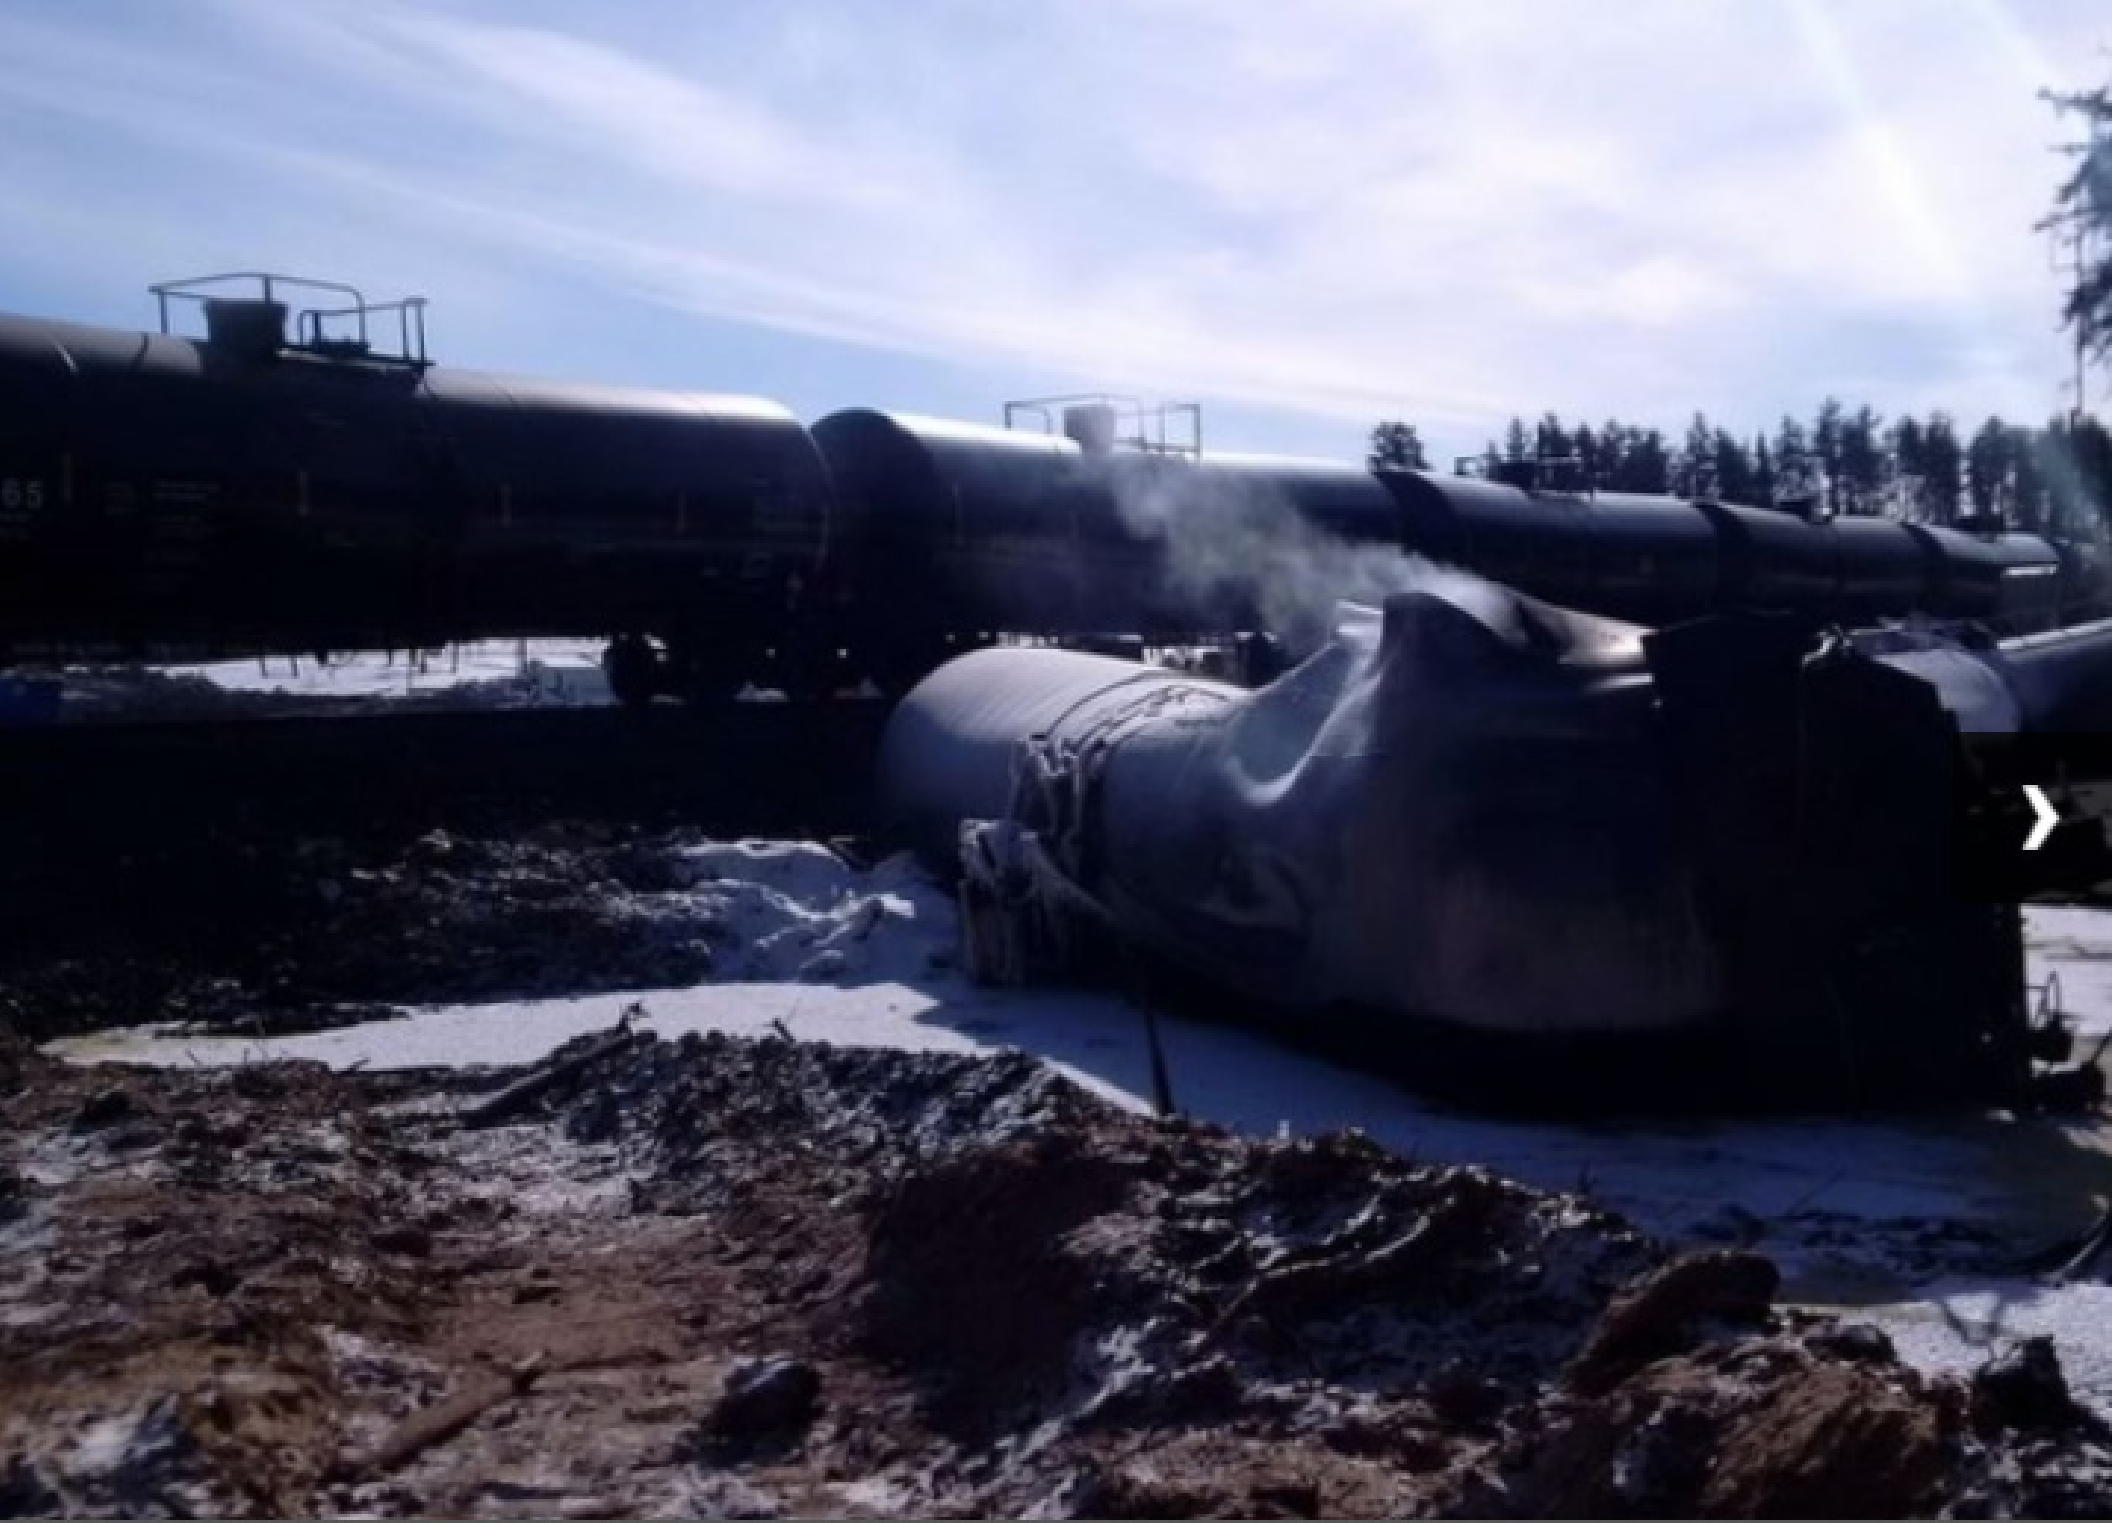
View of ruptured tank car next to the track. (TSB)
